US Army Corps  
of Engineers  
Construction Engineering  
Research Laboratories

Technical Report REMR-OM-19  
June 1997

# REMR Management Systems—Navigation and Flood Control Structures, Condition Rating Procedures for Lock and Dam Operating Equipment

by *James H. Stecker, Lowell F. Greimann, Scott Mellema, and Kevin Rens*  
*Department of Civil and Construction Engineering*  
*Iowa State University*

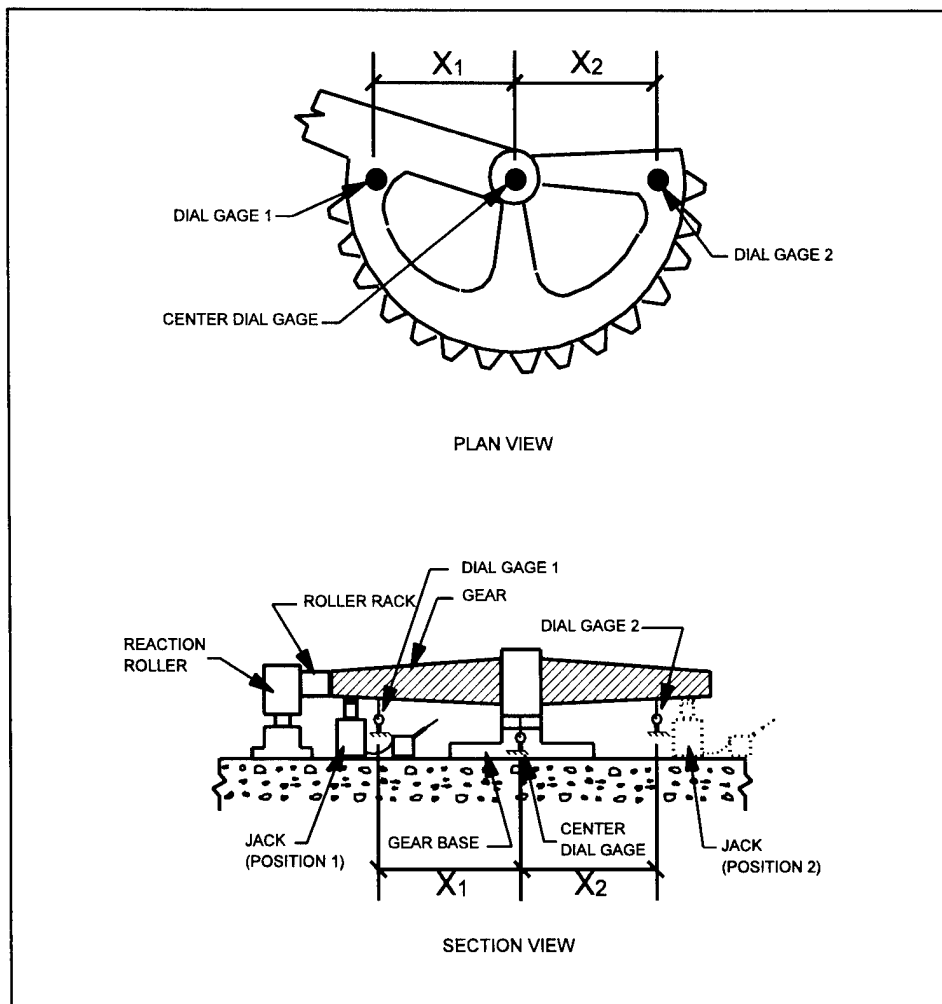
Figure A1. Bushing wear measurement.

Place three dial gages to measure the vertical displacement in the gear (Figure A1). Place one dial gage at the center of the gear. The remaining two dial gages should be placed an approximately equal distance,  $X_1$  and  $X_2$ , from the center of the gear and as close to 180 degrees from each other as possible (Figure A1). To prevent errors in readings, place all dial gage plungers in the same direction. Record the initial dial readings for all dial gages. Place a jack near one of the dial gages and begin jacking. Precaution should be taken while jacking the gear to ensure overloading does not occur. Record the dial gage readings after jacking (Figure A2). Next, release the jack and again take the dial gage readings. Place the jack 180 degrees from the initial position (near the other dial gage) and again jack and record the dial gage readings (Figure A3). Release the jack and record the dial gage readings.

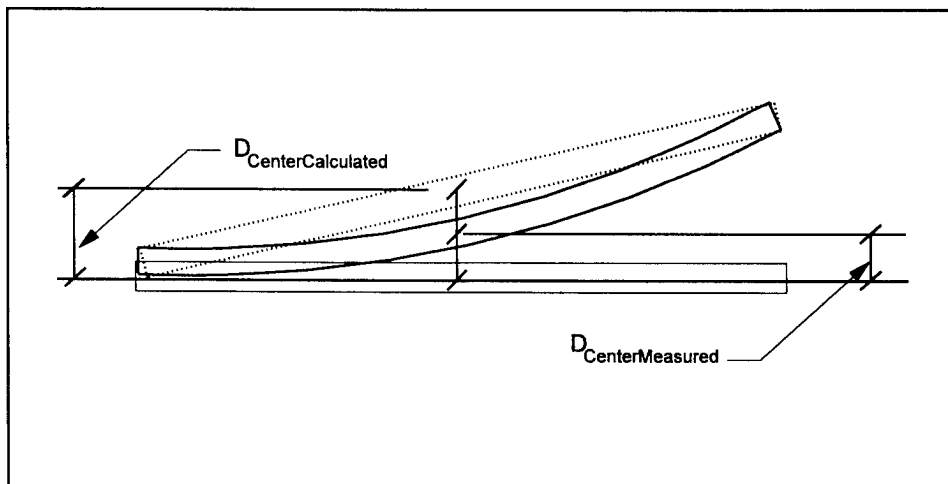
Figure A4. Displaced shape of gear (bowed and unbowed).

The limiting value for vertical displacement of an exposed gear that rotates on a bushing is 1/16 in. per foot of gear radius. This corresponds to an angle of rotation of 0.0026 radians or 0.15 degrees.

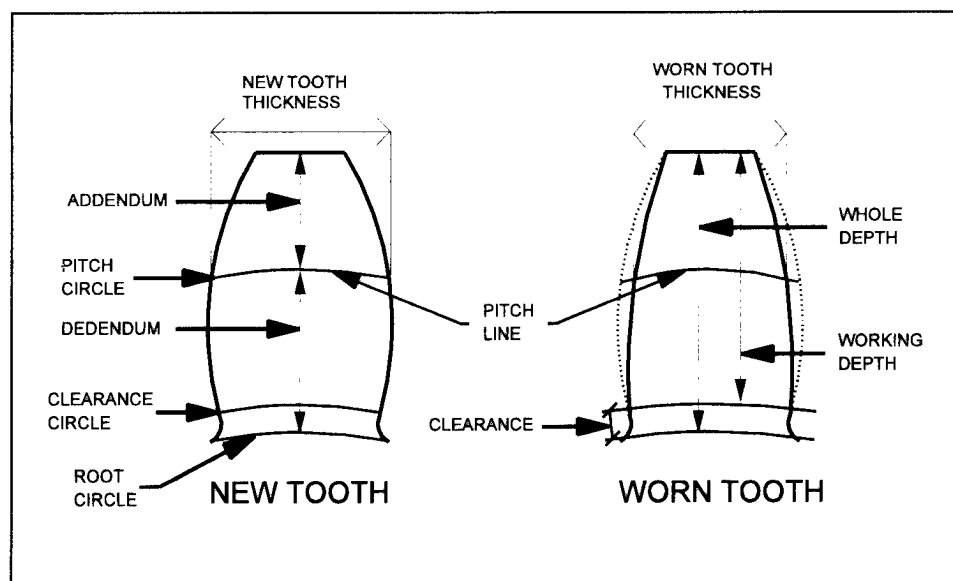
Figure B1. Gear tooth dimensions and wear measurement.

To inspect and rate gear and rack tooth wear, familiarity with the nomenclature used in describing gear and rack teeth is necessary; definitions for the various tooth relationships are presented in the following paragraphs and shown in Figure B1.
